Your Inspection Report

1973 Ontario Ave
Sample, ON L0L 5H3

Saturday, November 30, 2019

Report No. 1798, v.2

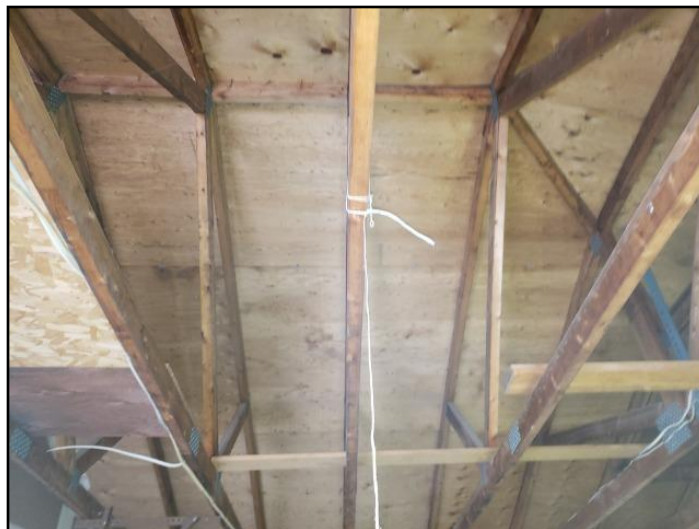
1. Condition: • Garage roof not vented - Recommend adding a roof vent to the garage to help prevent premature aging of the shingles.

1. Garage roof not vented - Recommend adding a...

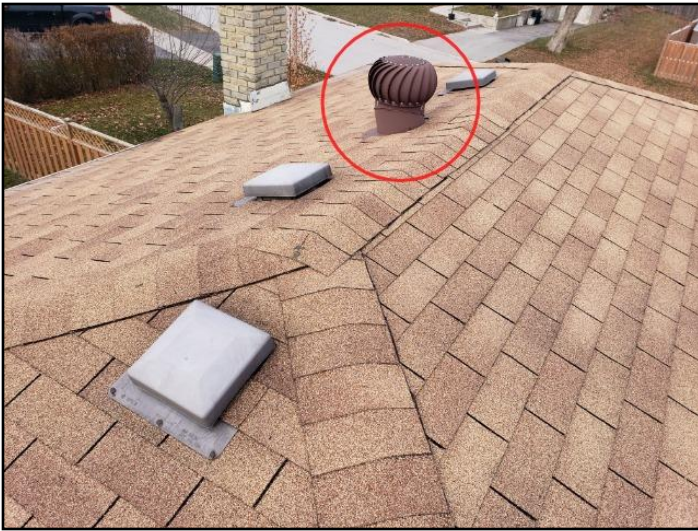
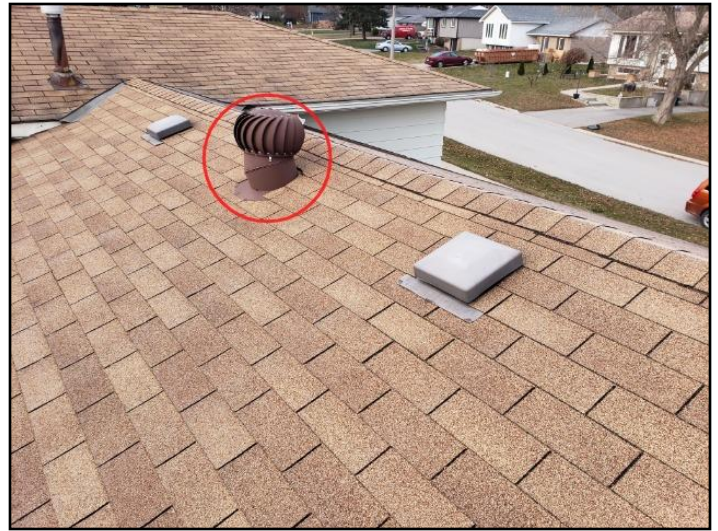
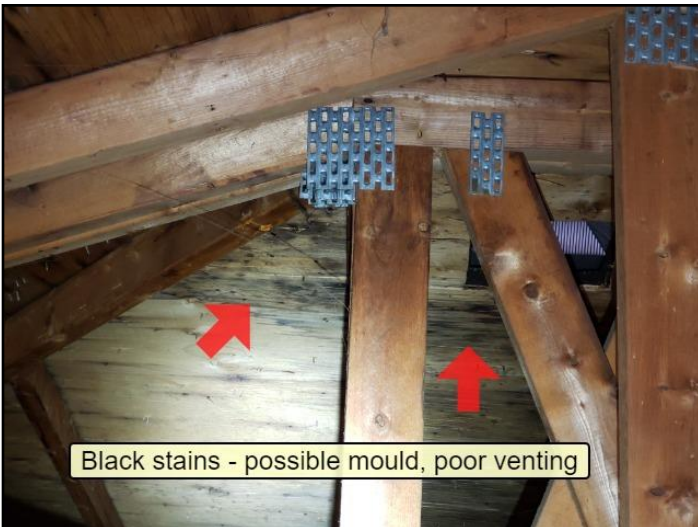
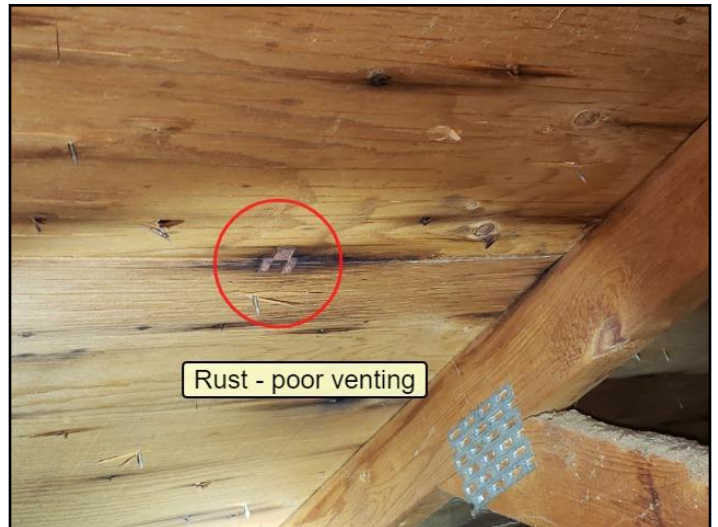
Mixing a turbine vent with static vents may cause the roof ventilation to suffer. Recommend improving the situation by having only one type of roof vent installed.

2. Installed improperly

3. Installed improperly

4. Installed improperly

5. Installed improperly

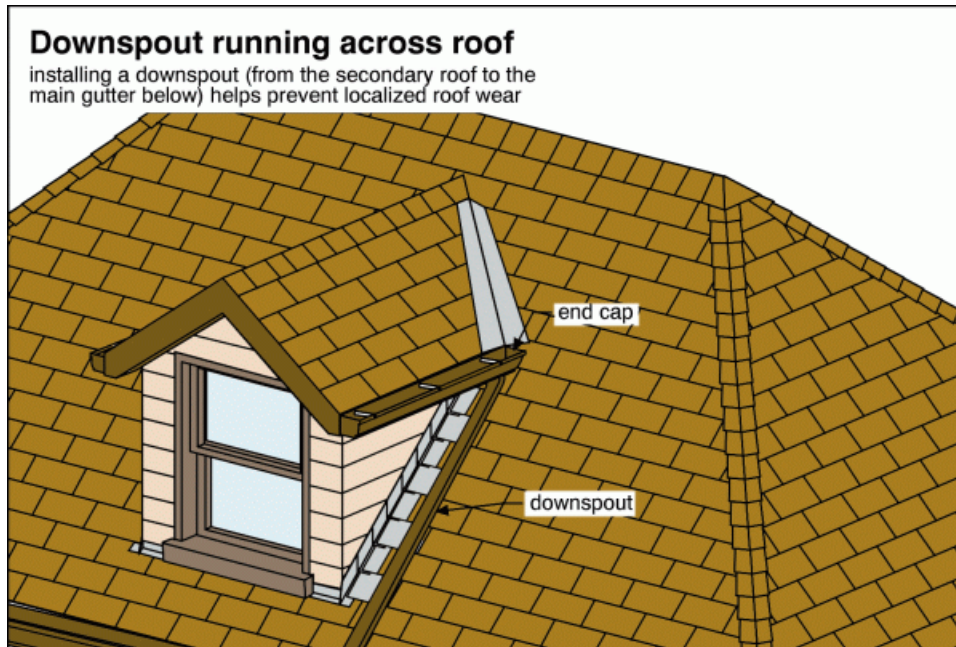
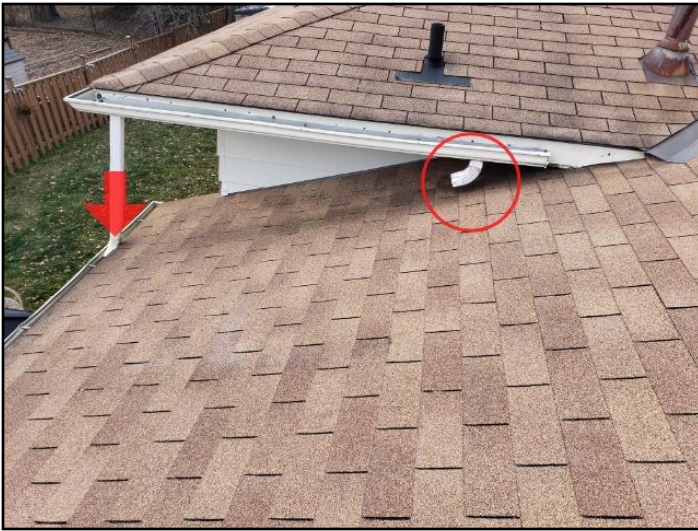
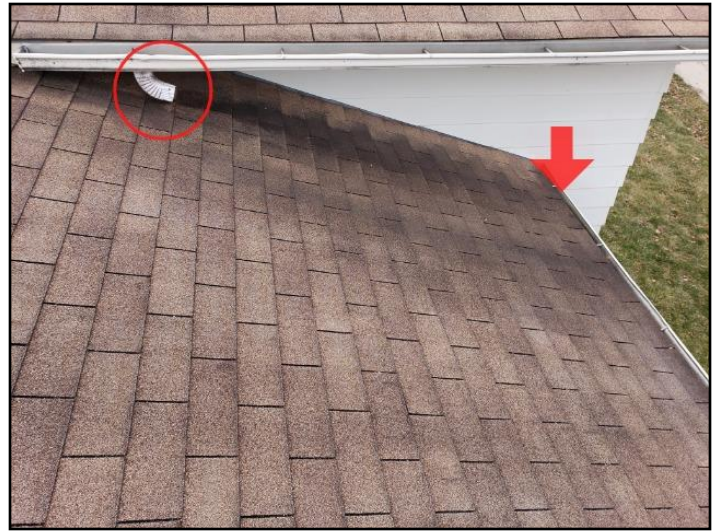
As pictured, the eaves trough is draining onto the lower roof. This will result in a shorter life for shingles underneath. Recommend extending the down spout to the lower eavestrough.

6. Discharge onto roofs

7. Discharge onto roofs

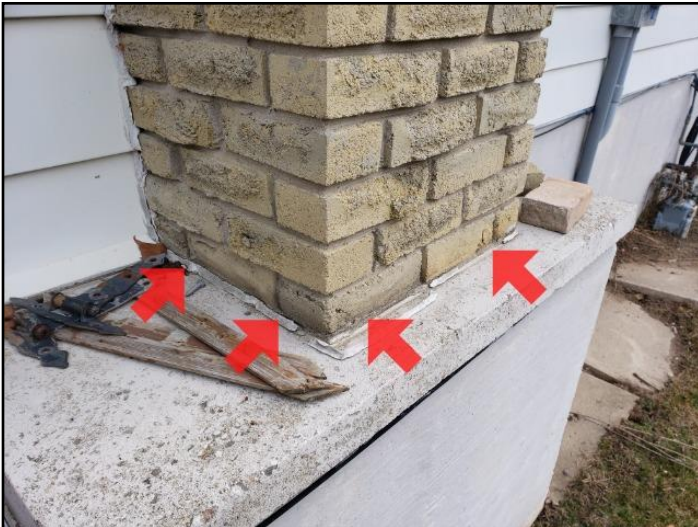
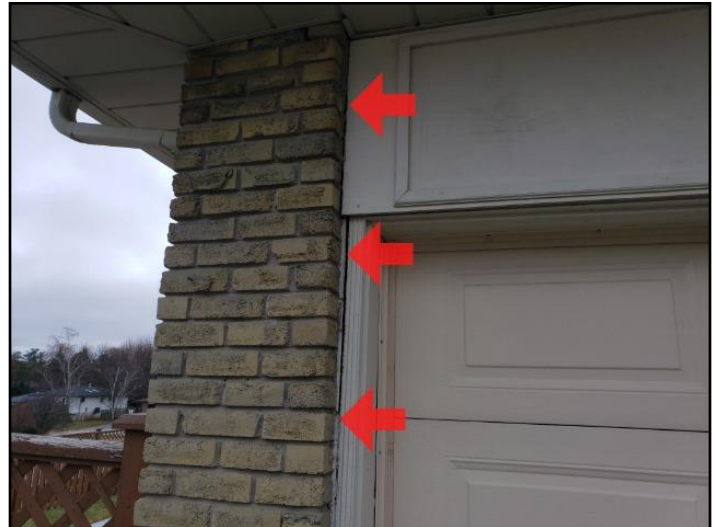
Where caulking is dried, separated or cracked, it should be removed and replaced.

8. Caulking missing or deteriorated

9. Caulking missing or deteriorated

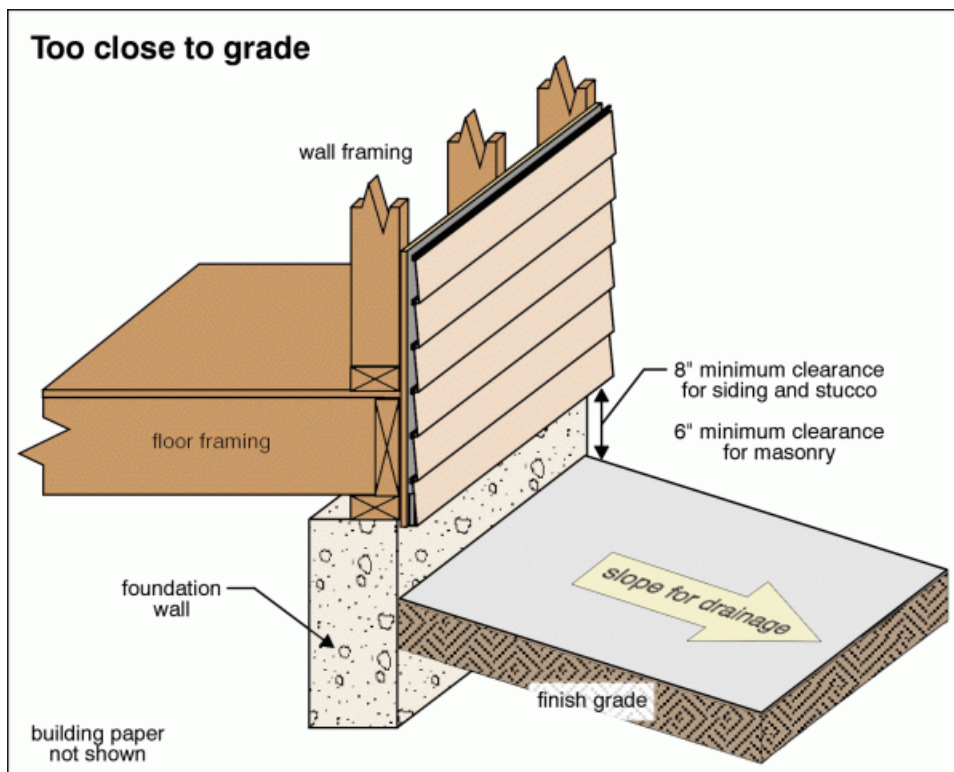
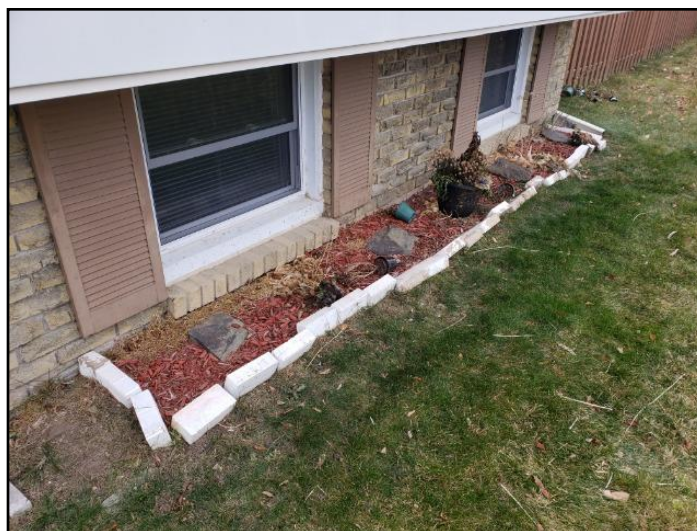
5. Condition: • [Too close to grade](#)

10. Too close to grade

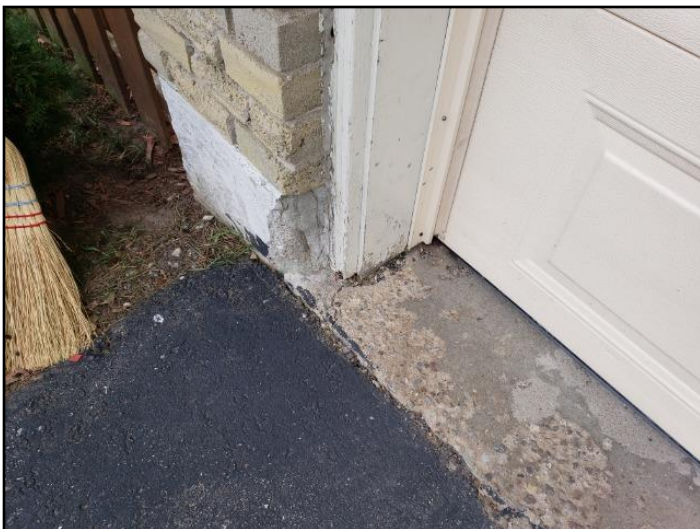
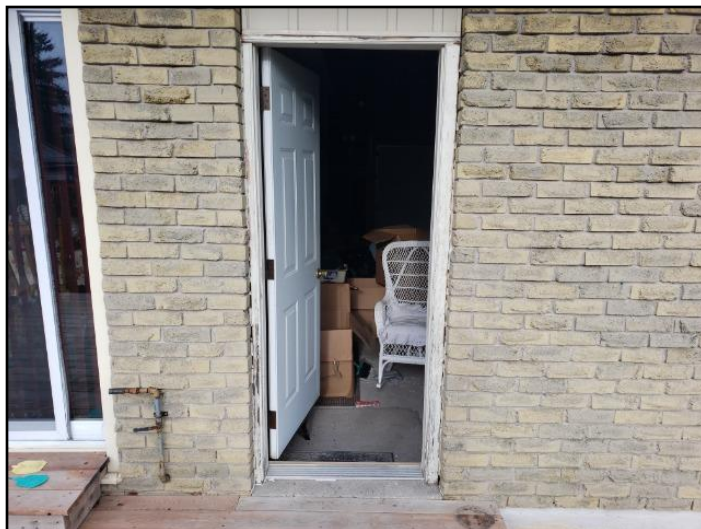
6. Condition: • [Paint or stain needed](#)

11. *Paint or stain needed*

12. *Paint or stain needed*

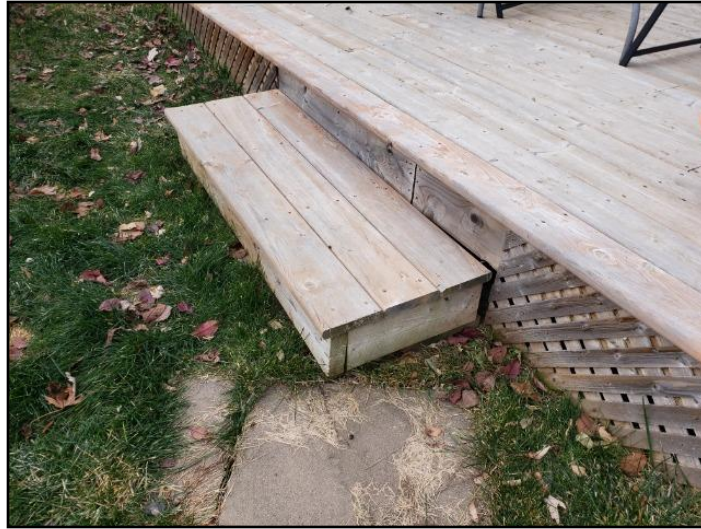
The rear deck step is loose and needs to be secured.

13. Trip hazard

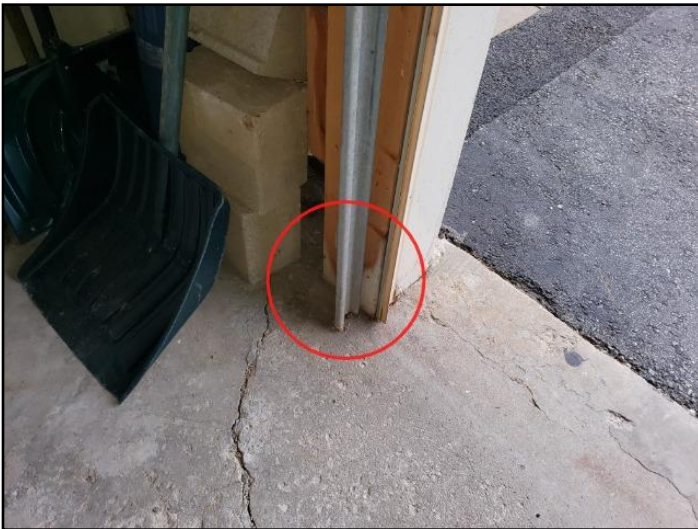
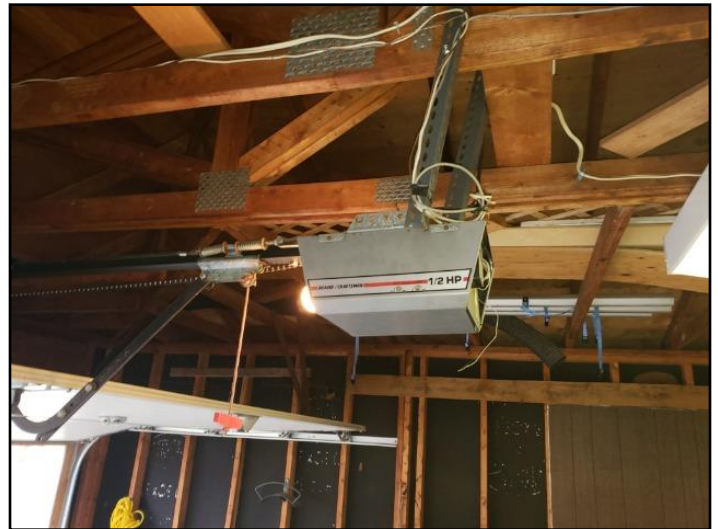
The garage door opener does not have safety sensors, which should be installed immediately. Due to the age of the opener, replacement of the opener may be required.

14. Sensors poorly located

15. Sensors poorly located

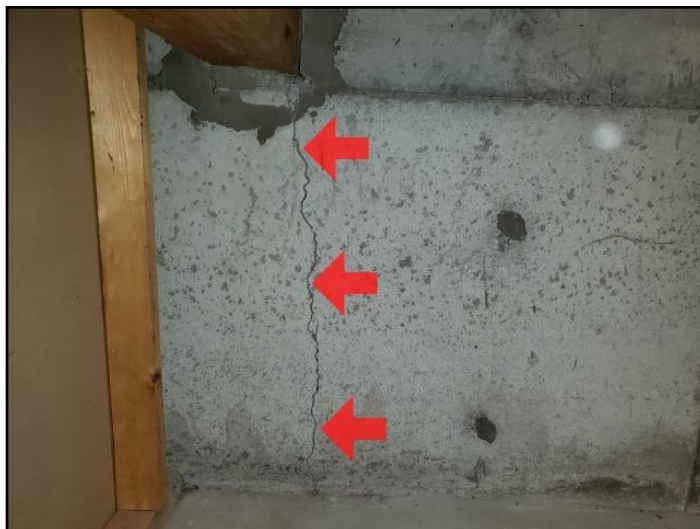
There is a large crack in the foundation at the left side of the house. Recommend immediate evaluation by a qualified foundation repair contractor with corrective action as required. No signs of increased moisture were found in the basement, although repair is strongly recommended.

16. Cracked

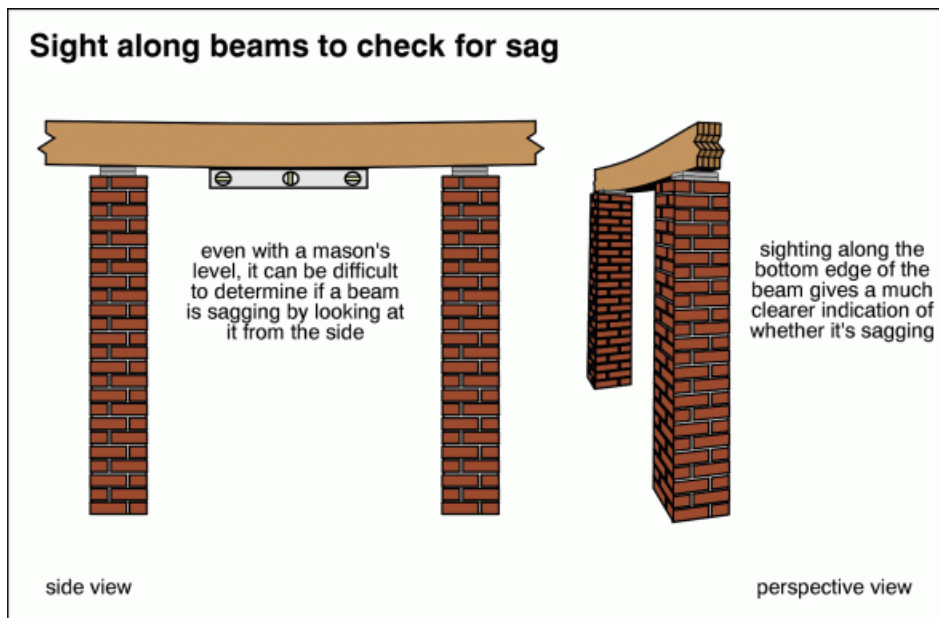
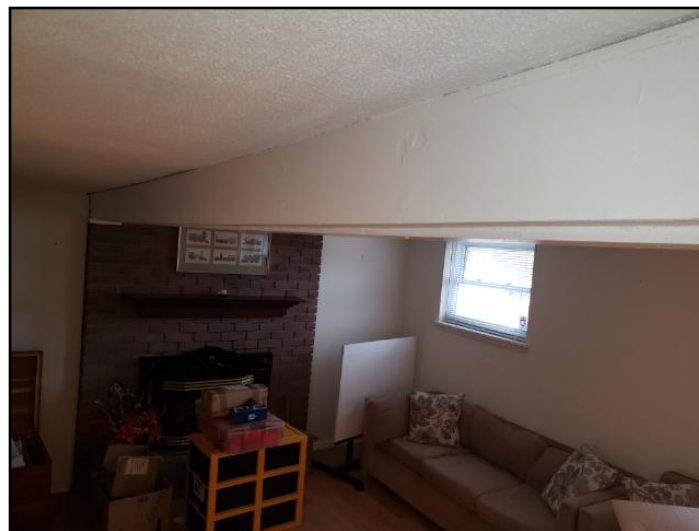
The beam in the basement living room appears to have a sag although it is clad in wood and not visible. Recommend removing the cladding when remodeling and further evaluation; corrective action as required. No significant sag noted on the floor above.

17. Sag

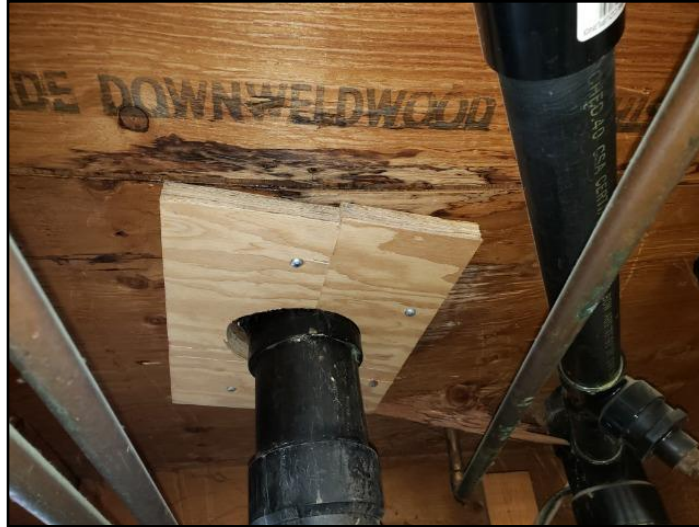
The floor below the main bathroom shows rot and water damage below the toilet; the joist has been removed in this area. Recommend evaluation by a qualified contractor and corrective action to properly support the floor.

18. Rot

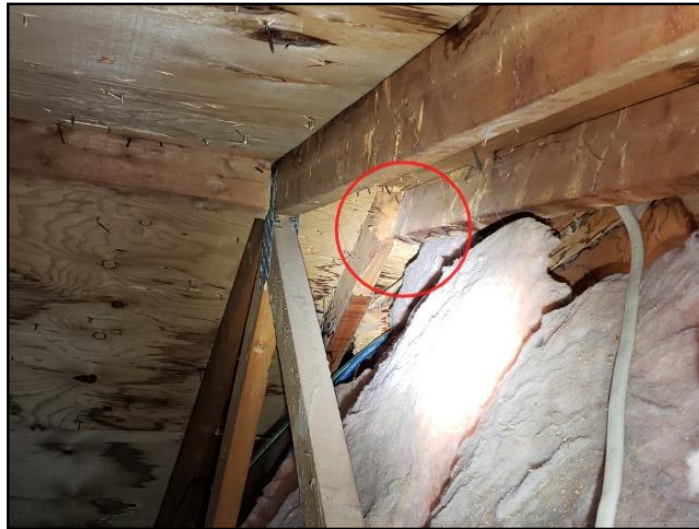
The rafters at the junction of the lower attic and upper floor have separated and need to be repaired by a qualified contractor.

19. Weak connections

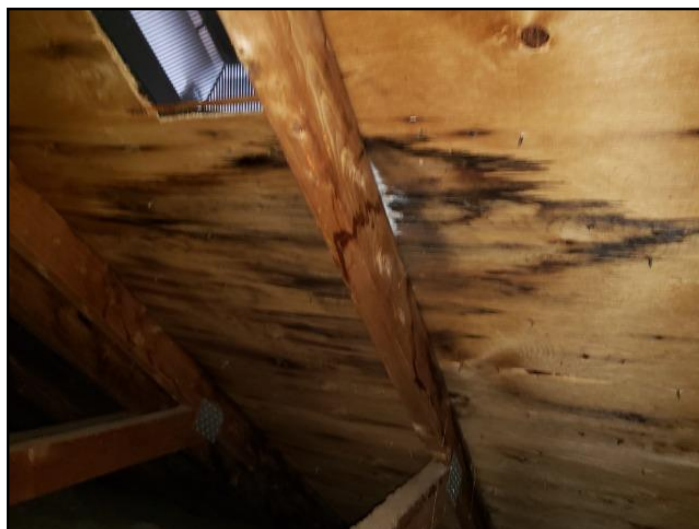
The staining and apparent growth on the attic sheathing in the upper attic may be mould growth. Recommend improving attic ventilation (as noted in the roofing section of this report), cleaning the area with an anti-microbial cleaner and annual monitoring.

20. Mold

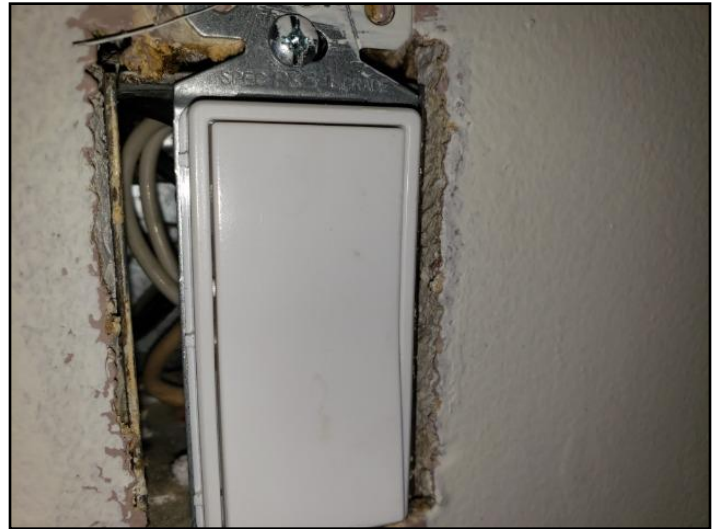
The house is wired with aluminum wiring. Many of the fixtures and outlets / switches are "Decora" style and need to be verified certified for aluminum. Recommend immediate further evaluation by a licensed electrical contractor, with repair as required.

22. Connectors not compatible with aluminum

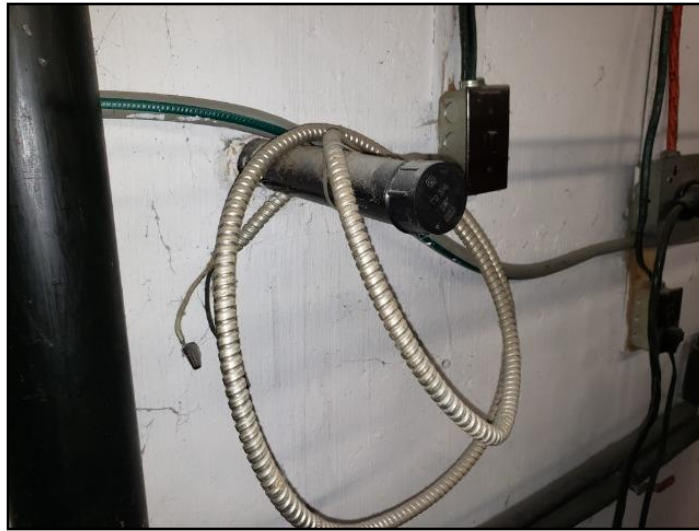
The wire pictured is above the laundry appliances. Recommend immediate repair or removal by a licensed electrical contractor.

23. Abandoned wire

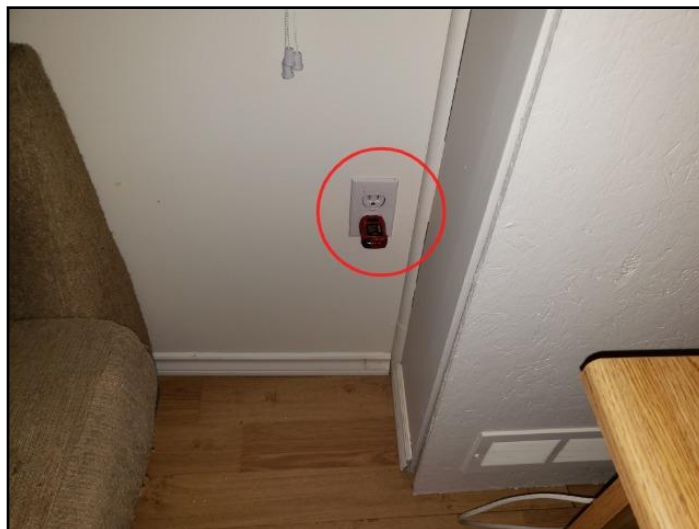
The outlet pictured is inoperative and needs repair by a licensed electrical contractor.

24. Inoperative

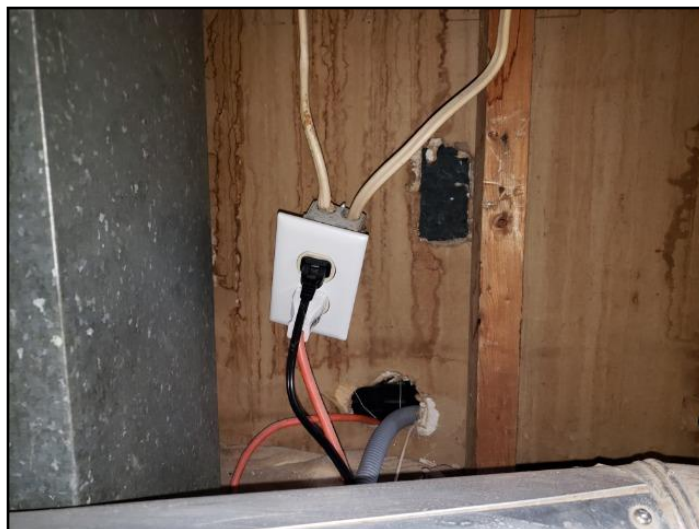
The outlet shown is loose and needs to be secured.

26. Loose

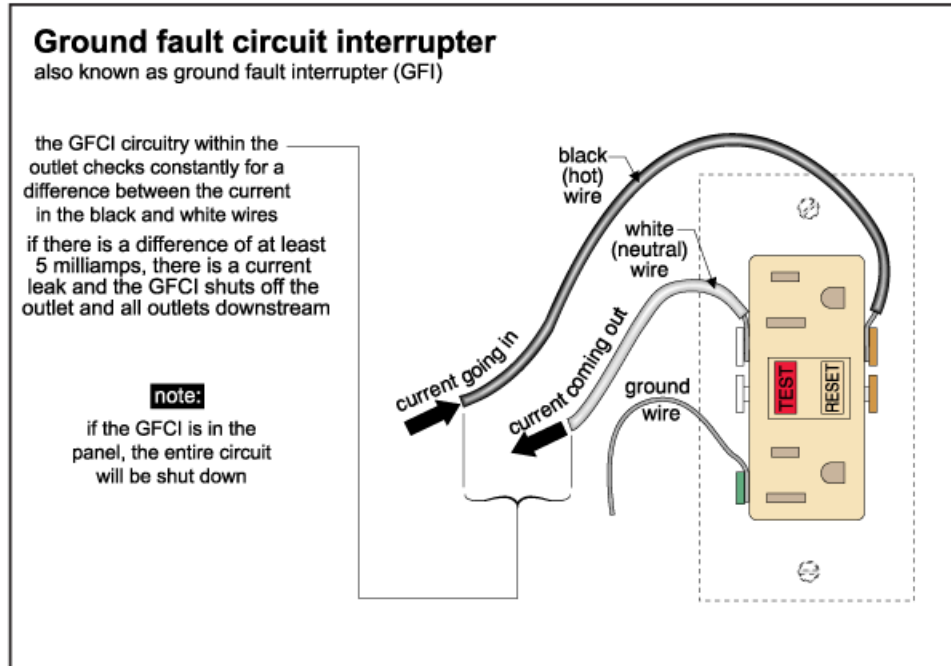
The outlets pictured (kitchen and all exterior) should be replaced with GFCI outlets by a licensed electrical contractor.

27. GFCI/GFI needed (Ground Fault Circuit...

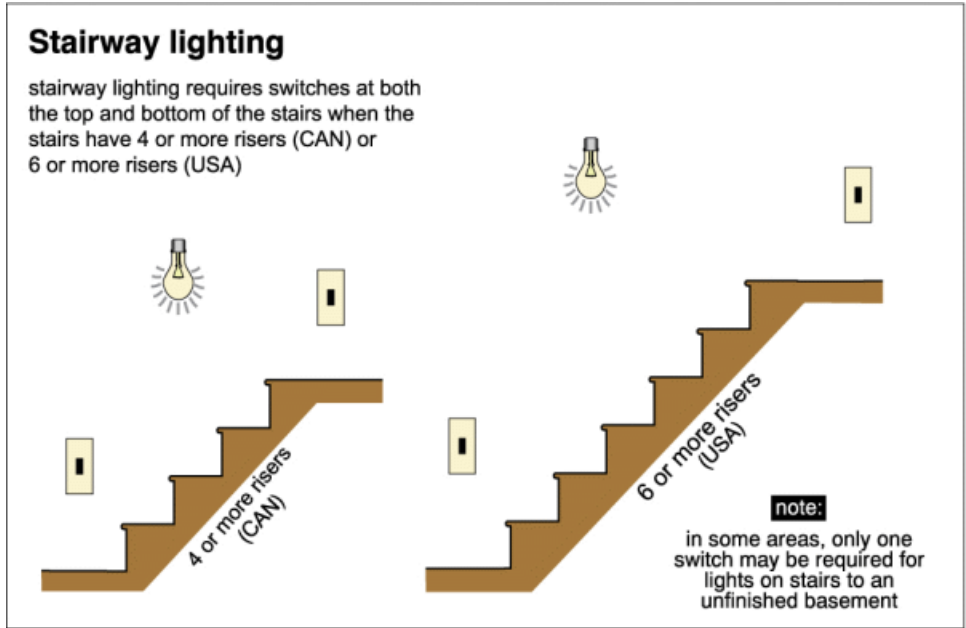
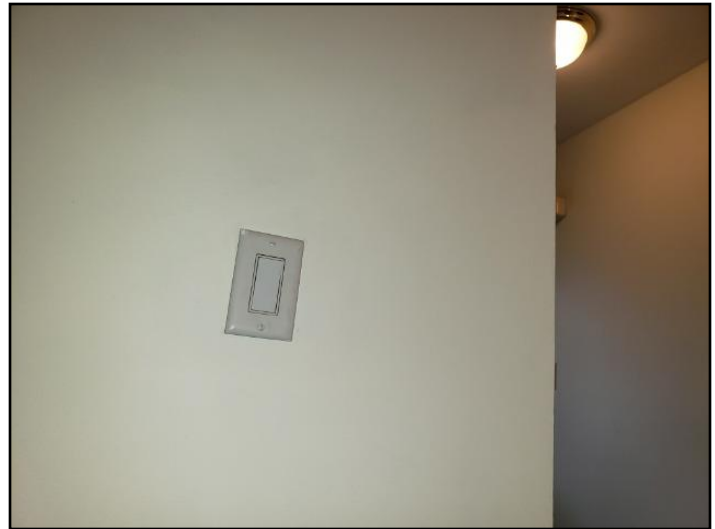
The three way switch set up in the basement does not work as intended, and needs to be repaired by a licensed electrical contractor.

28. 3-way not working as intended

29. 3-way not working as intended

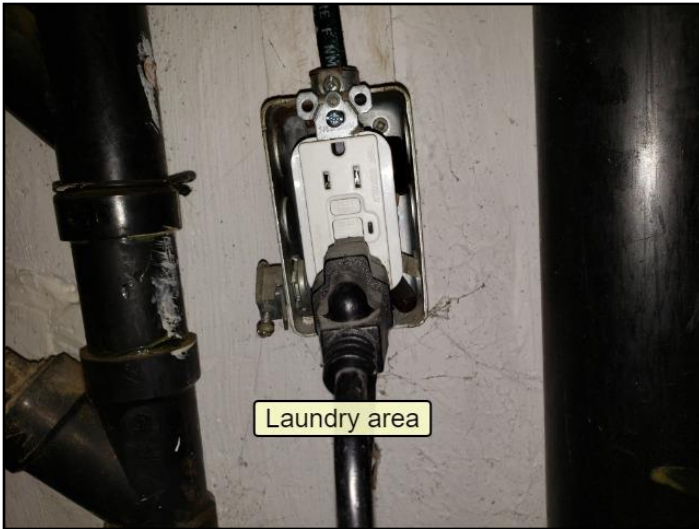
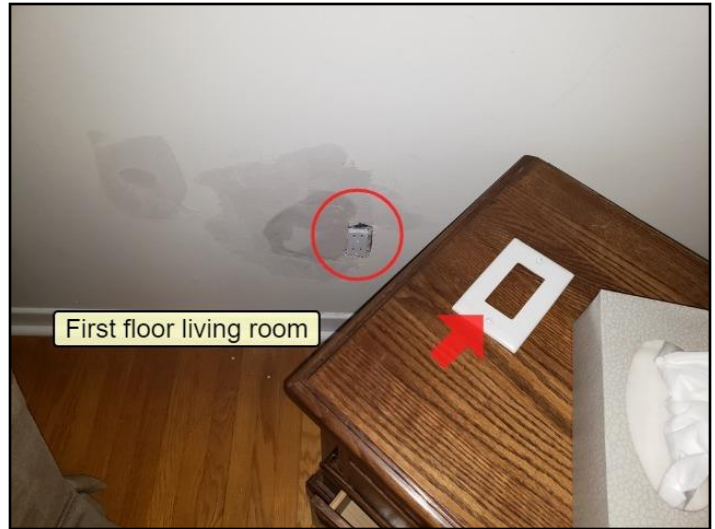
Provide for any missing cover plates on outlets and switches immediately.

30. Missing

31. Missing

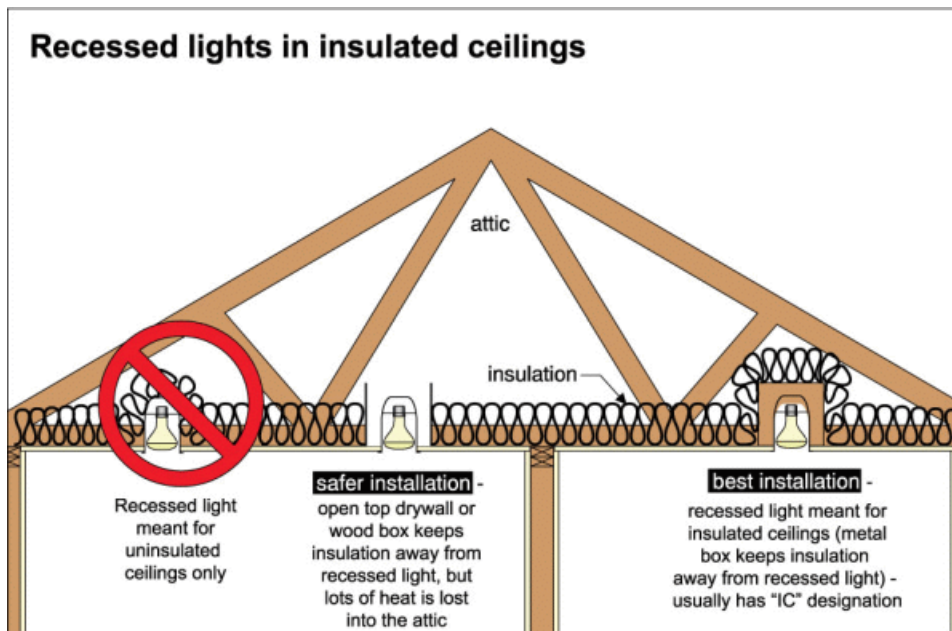
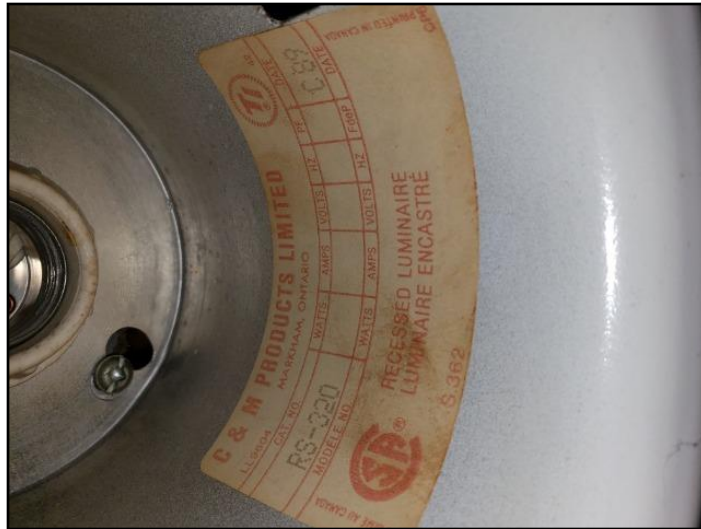
The potlights in the kitchen are not rated for insulated ceilings, and should be replaced with IC rated potlights by a licensed electrical contractor.

32. Improper potlights

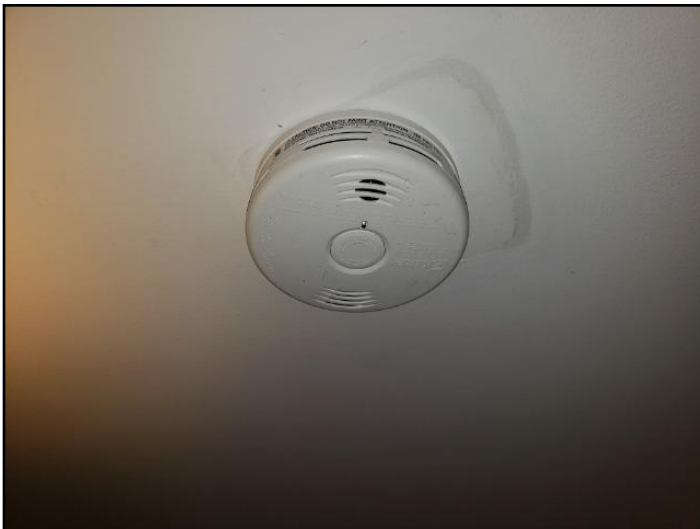
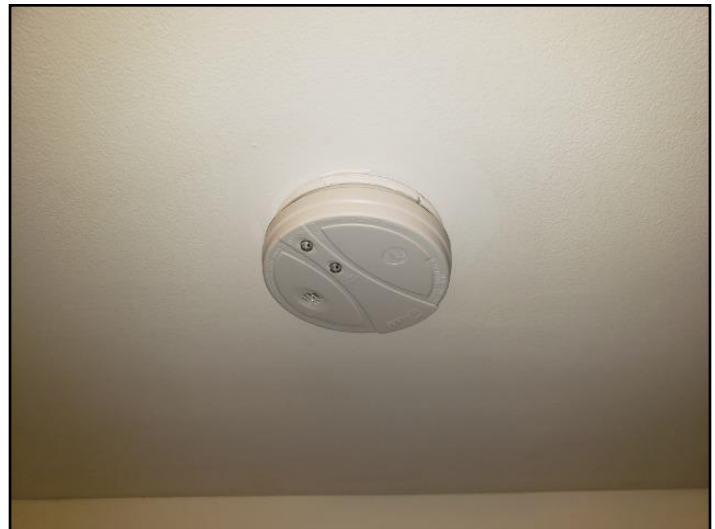
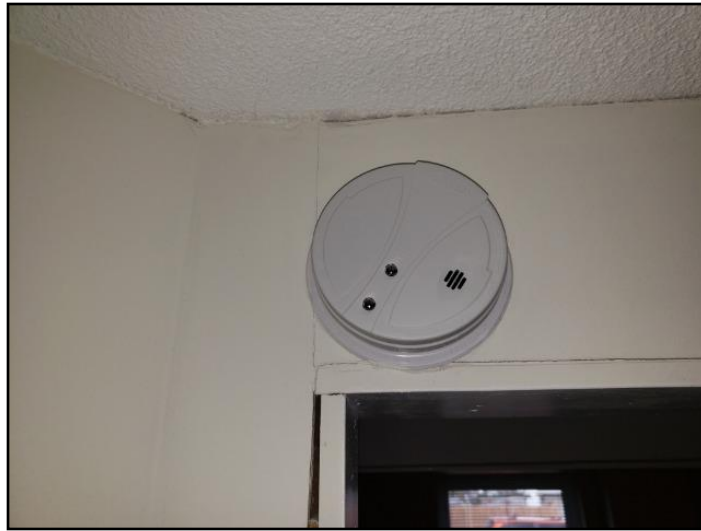
23. Condition: • Home Advantage recommends replacing smoke alarms with new, combination Smoke / CO alarms as per the Ontario Fire Code Requirements.

33. Home Advantage recommends replacing smoke...

34. Home Advantage recommends replacing smoke...

35. Home Advantage recommends replacing smoke...

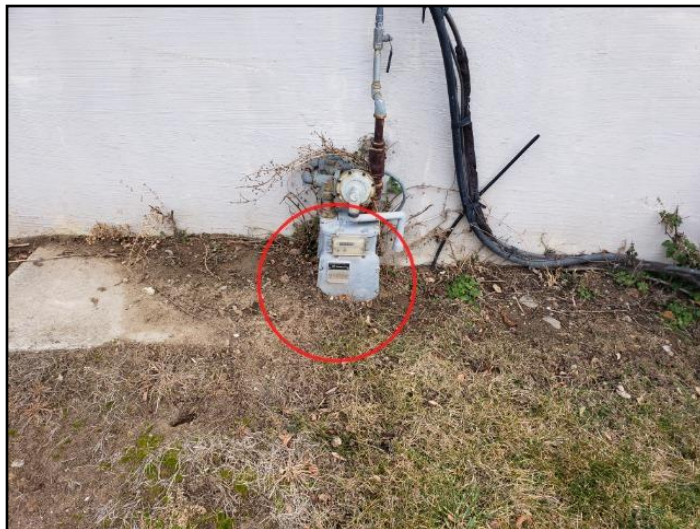
The gas meter is at grade level, partially submerged in the soil. Recommend the utility improve the situation.

36. Poor location

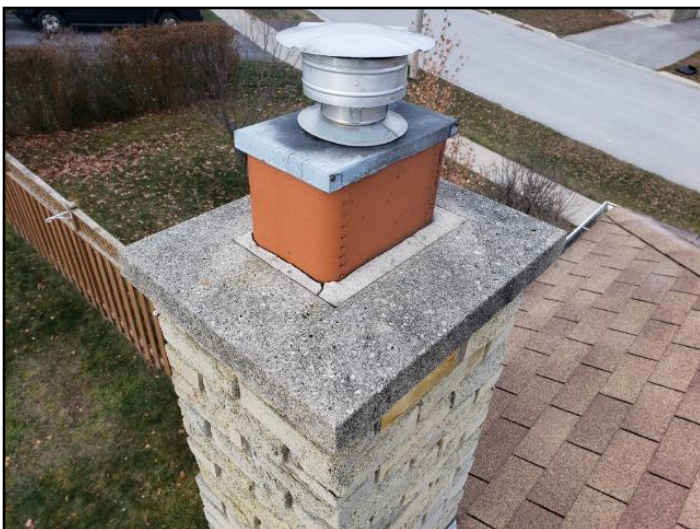
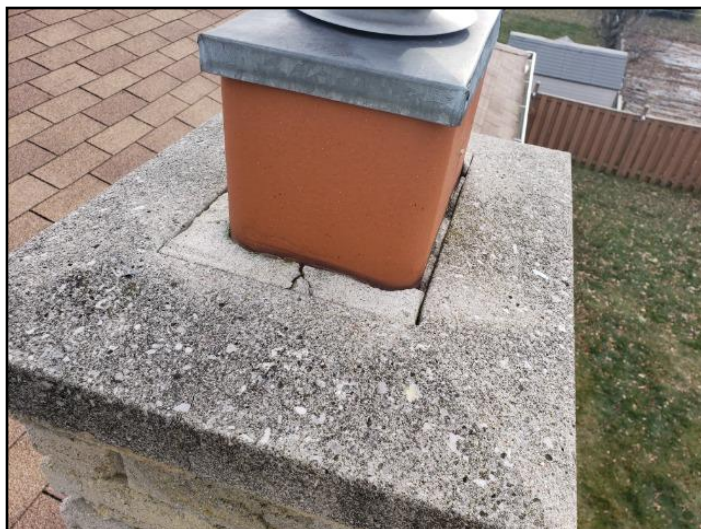
25. Condition: • Open Seams - Recommend sealing the seams at the chimney cap to help prevent water entry.

37. Open Seams - Recommend sealing the seams at...

38. Open Seams - Recommend sealing the seams at...

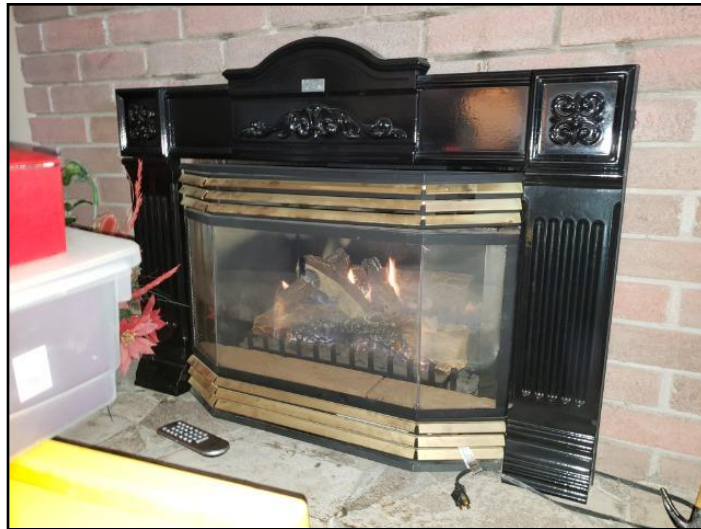
39.

Condition: • Possible exhaust leak - When operated, a strong smell of exhaust was noted at the basement gas fireplace. Possible exhaust leak. Recommend further evaluation by a qualified installer, with corrective action as required.

26. Condition: • Possible exhaust leak - When operated, a strong smell of exhaust was noted at the basement gas fireplace. Possible exhaust leak. Recommend further evaluation by a qualified installer, with corrective action as required.

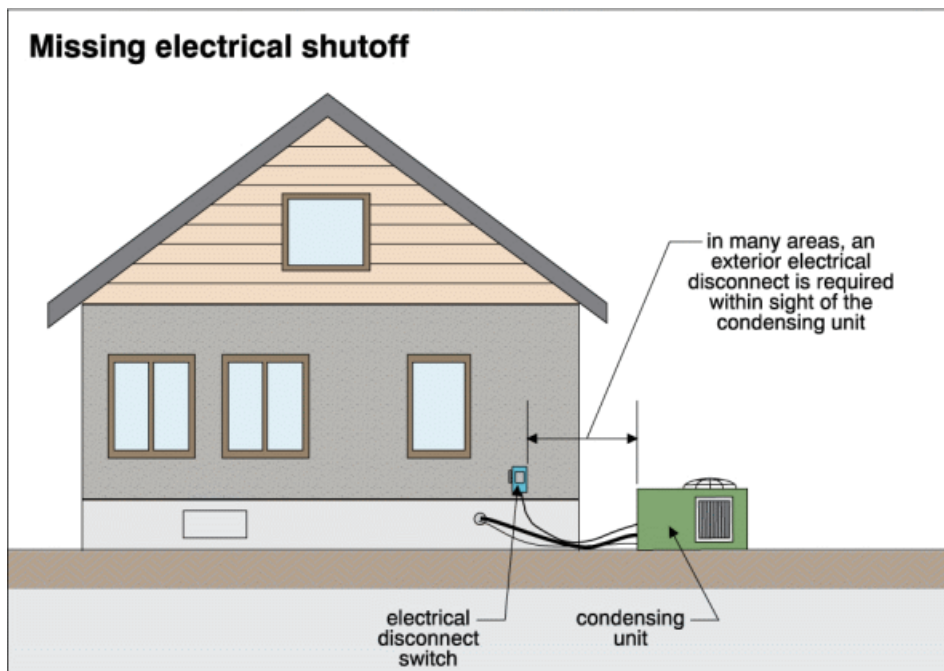
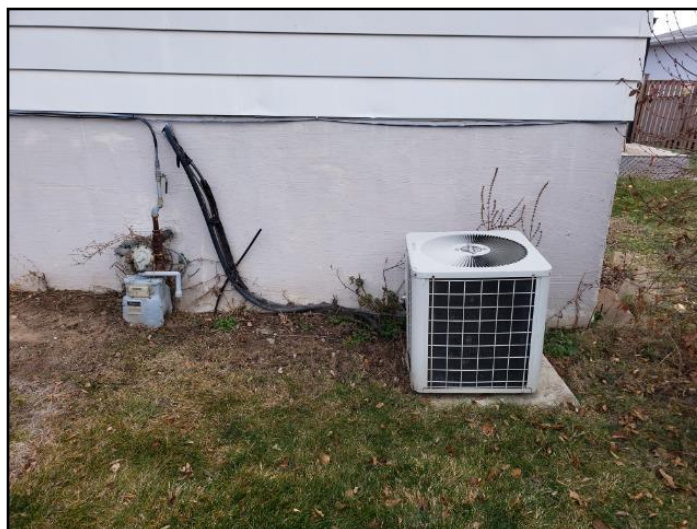
The outdoor compressor unit for the air conditioning system needs a proper electrical shutoff installed by a licensed electrical contractor.

40. *Missing electrical shutoff*

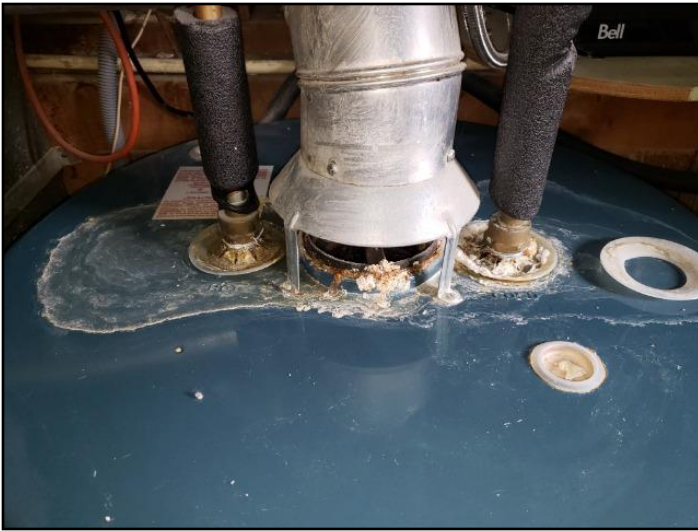
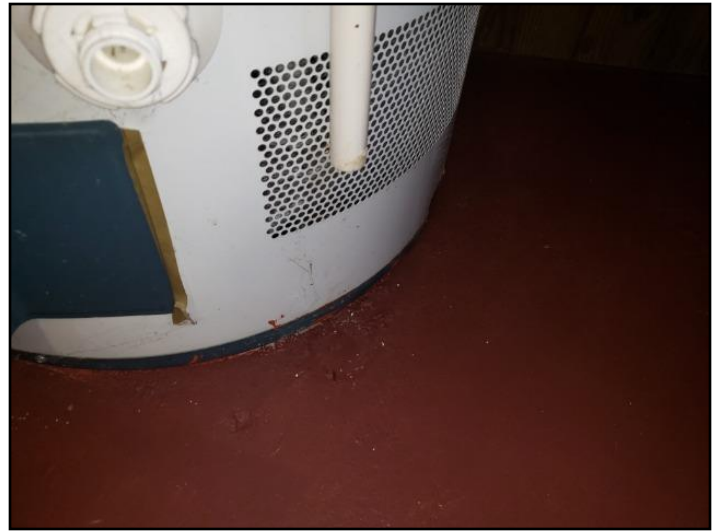
28. Condition: • Past Life Expectancy - The water heater is 11 years old, the pressure relief valve is leaking and signs of back-drafting / corrosion are present at the flue. Due to the age of the heater, it is recommended to replace it with a more efficient, newer unit.

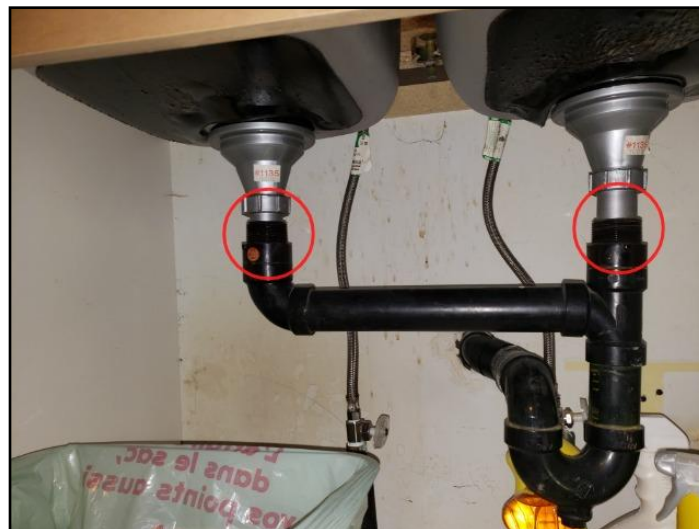
The connections shown have leaks and need immediate repair; Threaded connectors are missing.

43. Leak

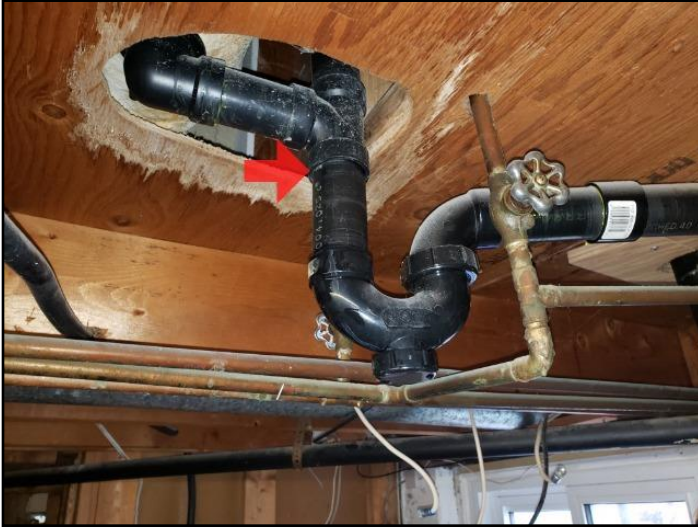
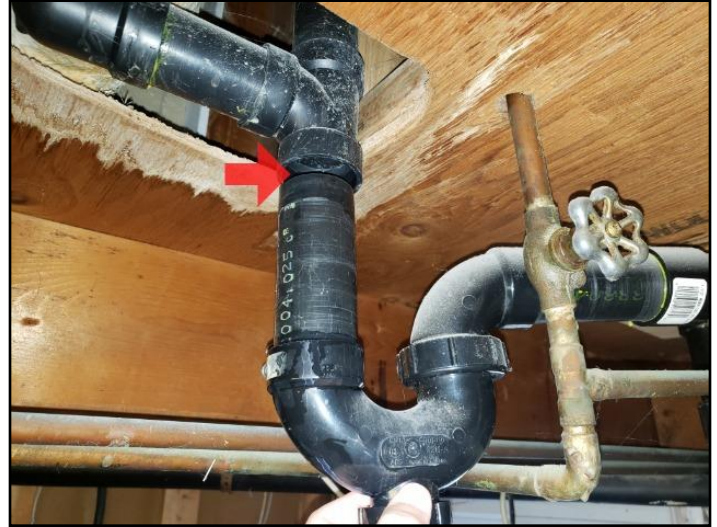
The bathtub drain is not properly connected in the basement. One connection is not glued and leaked significantly during the inspection. Recommend immediate repair by a licensed plumbing contractor.

44. Leak

45. Leak

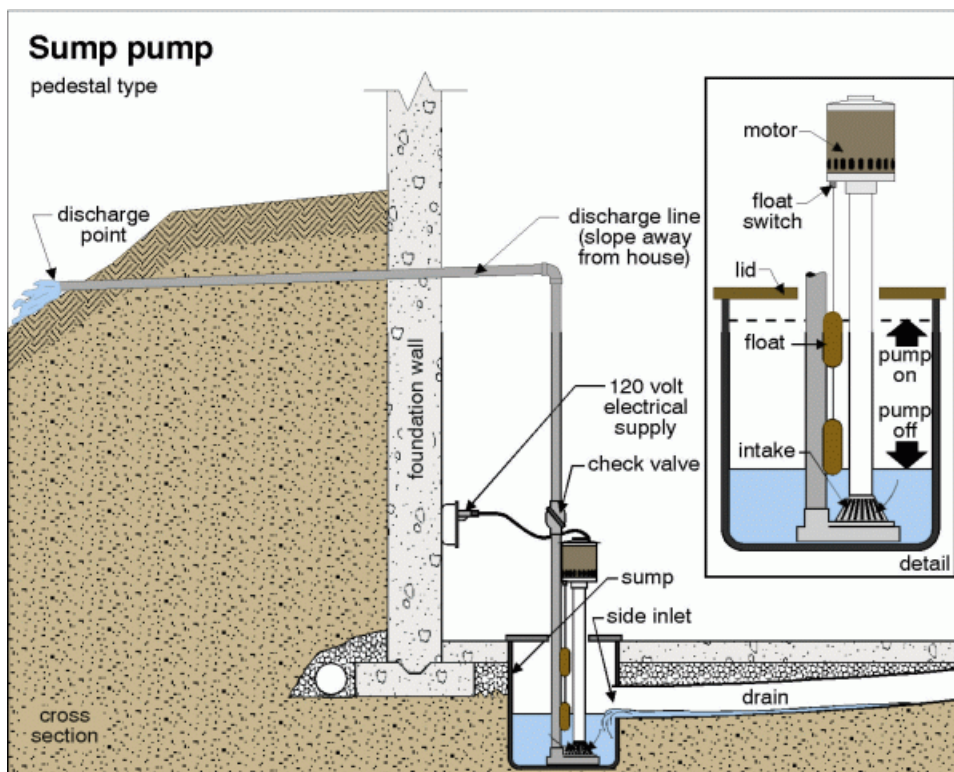
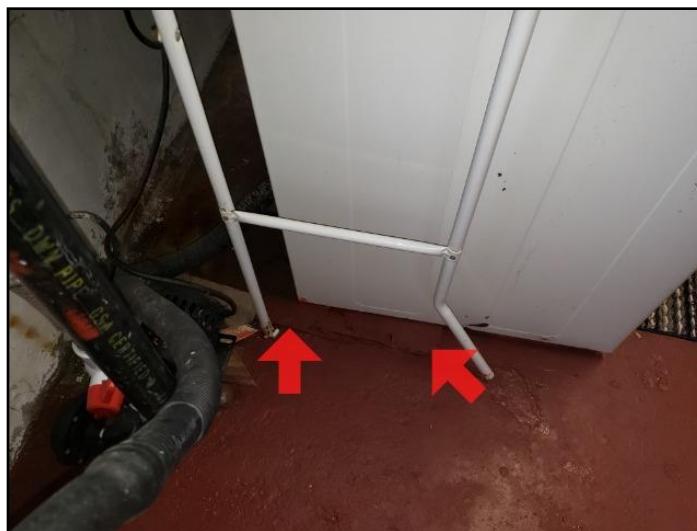
The sump well is covered with plywood under the washing machine, no pump is present. Recommend installing a proper sump pump and drainage, with a proper plastic lid.

46. Missing
