Your Inspection Report

1973 Ontario Ave
Sample, ON L0L 5H3

Saturday, November 30, 2019

Report No. 1798, v.2

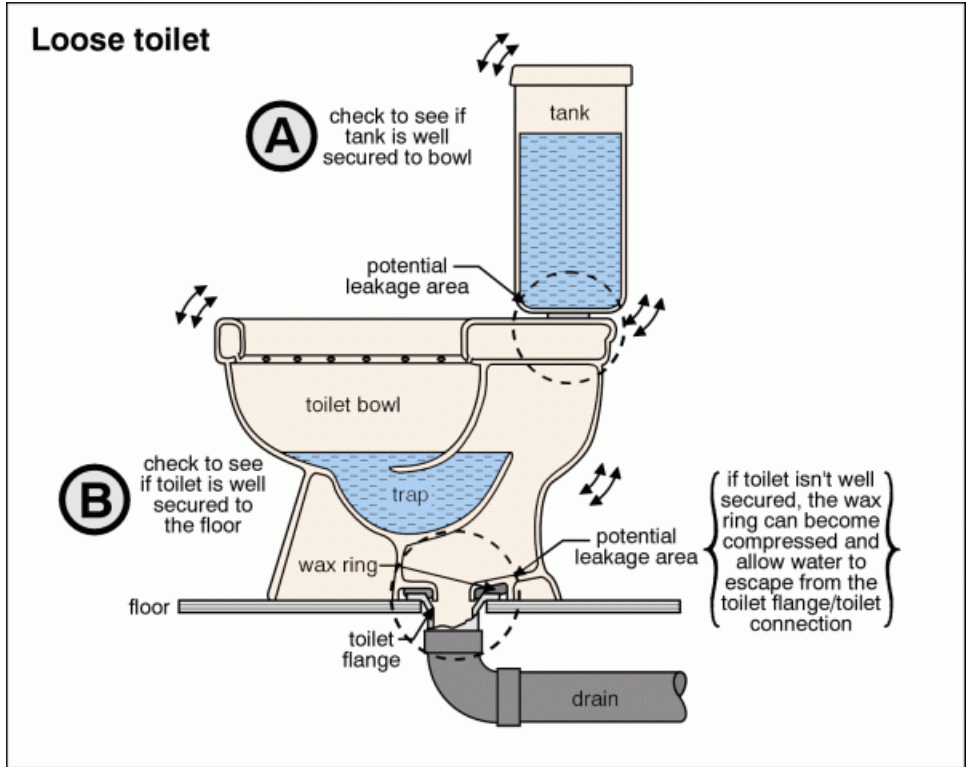
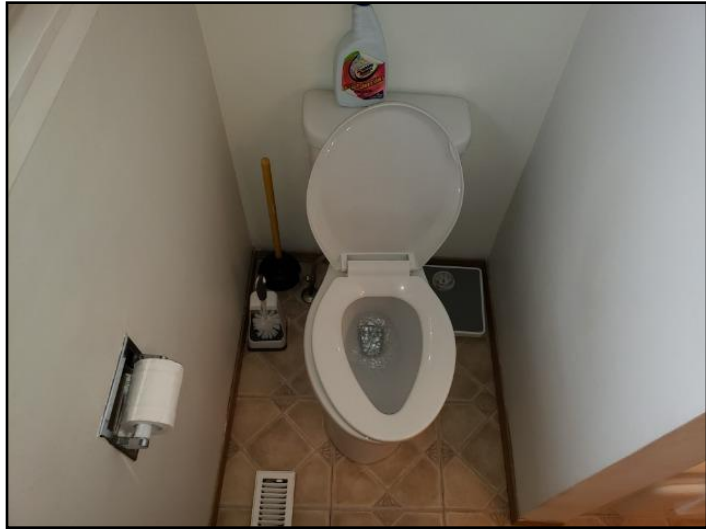
The main bathroom toilet is loose and needs to be repaired.

47. Loose

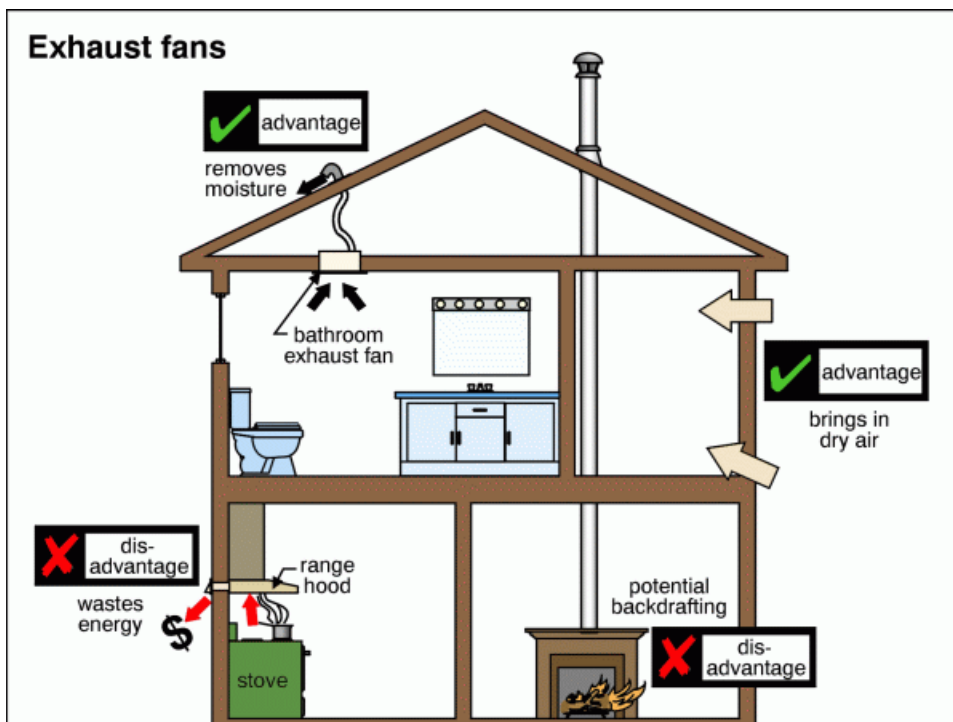
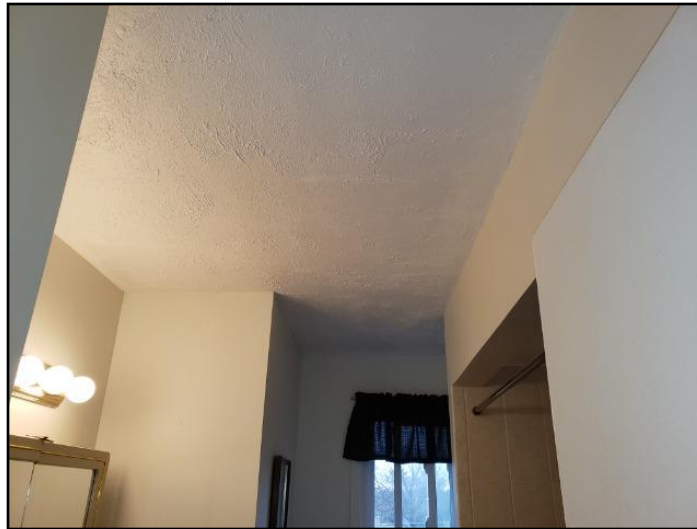
34. Condition: • [Missing](#)

Recommend installing a properly vented bathroom exhaust fan (vented to the exterior through the roof), when remodeling.

50. Missing

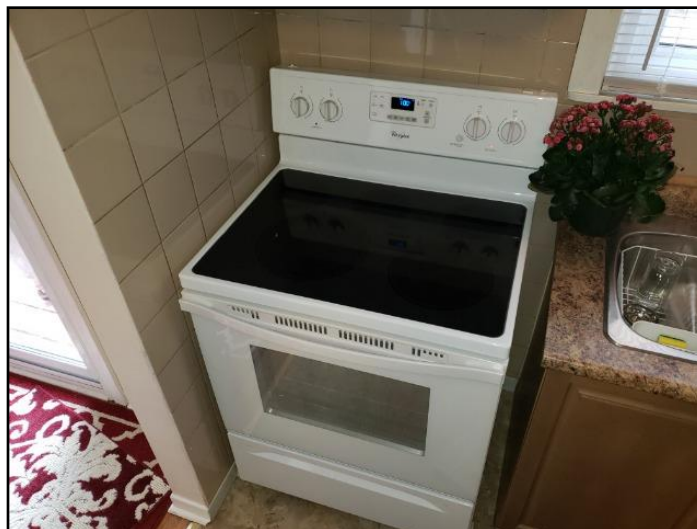
35. Condition: • Anti-tip device missing

51. Anti-tip device missing

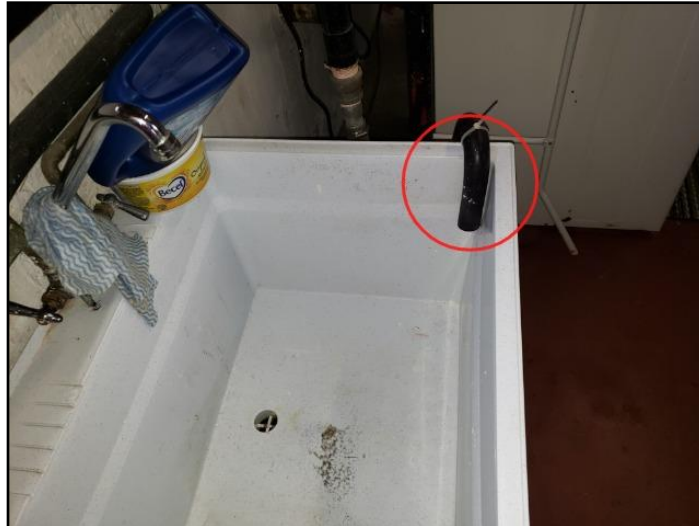
36. Condition: • Standpipe missing

52. Standpipe missing

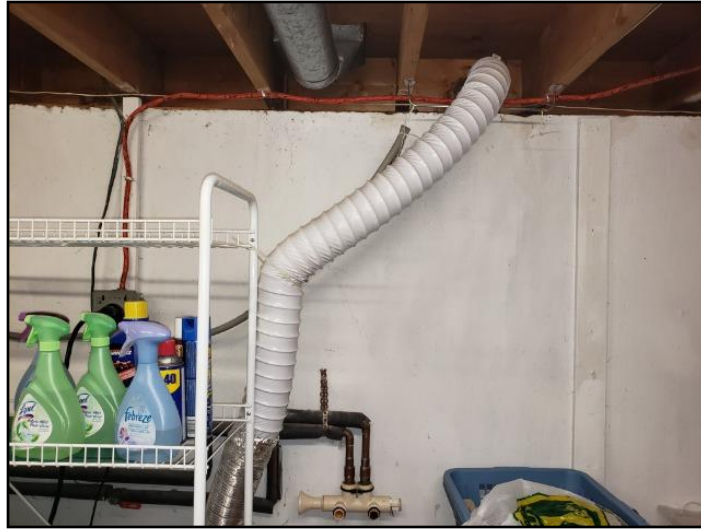
The plastic flex dryer vent is not safe. Recommend replacing it with either straight metal piping (best option), or metal flex duct.

53. Plastic dryer vent
