Your Inspection Report

1973 Ontario Ave
Sample, ON L0L 5H3

Saturday, November 30, 2019

Report No. 1798, v.2

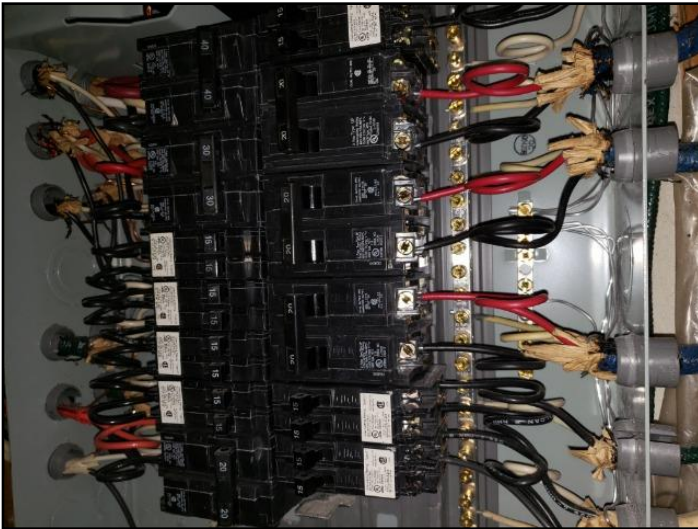
21. Connectors not compatible with aluminum

Condition: • [Connectors not compatible with aluminum](#)

The house is wired with aluminum wiring. Many of the fixtures and outlets / switches are "Decora" style and need to be verified certified for aluminum. Recommend immediate further evaluation by a licensed electrical contractor, with repair as required.

Implication(s): Fire hazard
